合約編號 TD 152/2012 銅鑼灣西區交通研究

摘要

二零一四年八月

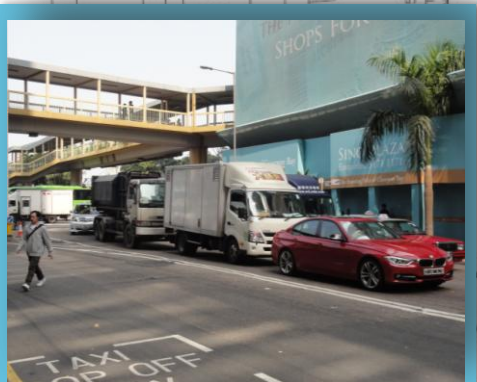
Traffic Queue at Junction Gloucester Road / Percival Street
告士打道 / 波斯富街路口出現車龍

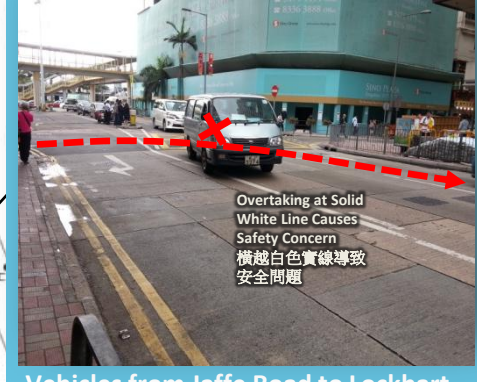
Vehicles from Jaffe Road to Lockhart Road Overtaking at the Solid White Line at Percival Street Causes Safety Concern
車輛從謝斐道轉入駱克道於波斯富街橫越白色實線導致安全問題

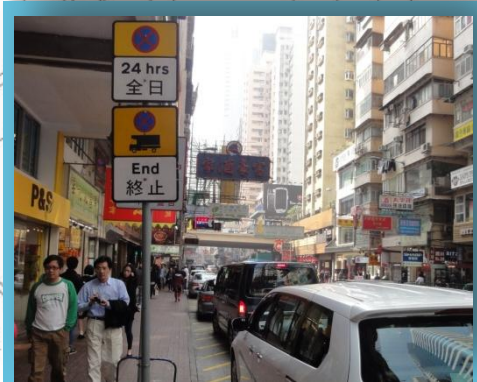
Illegal Parking Vehicles Occupying Loading / Unloading Bays at Lockhart Road
非法停泊車輛佔據駱克道上落客貨區

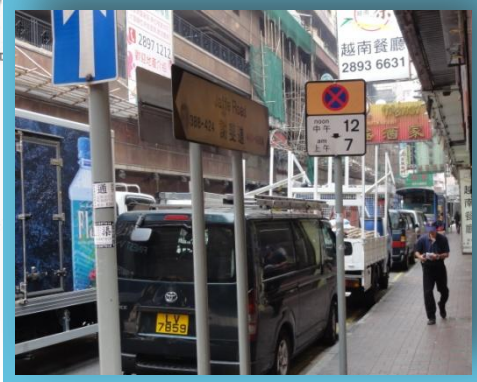
Illegal Parking Vehicles Occupying Loading / Unloading Bays at Jaffe Road
非法停泊車輛佔據謝斐道上落客貨區

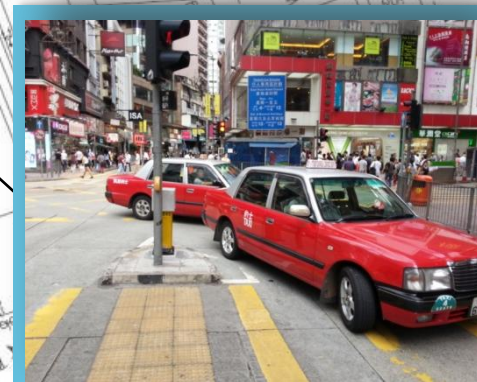
Large Vehicles Right Turn from Percival Street to Lockhart Road Maneuvering Problems Cause Safety Issues
大型車輛較難從波斯富街右轉入駱克道導致安全問題

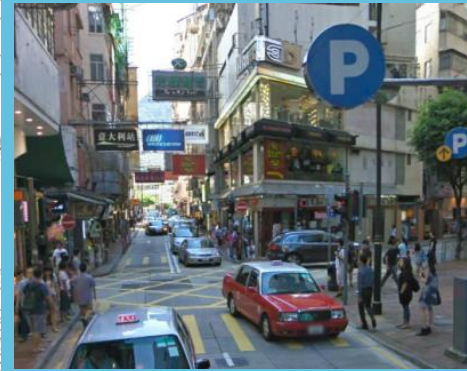
Left turn vehicles often blocked by queuing vehicles at Sharp Street East
霎東街車龍阻礙車輛左轉

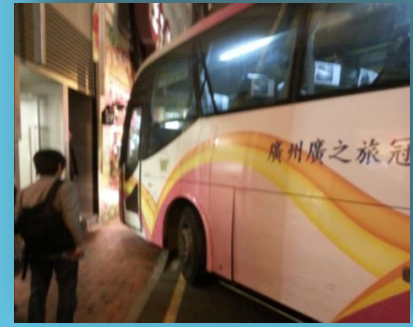
Large Vehicles Right Turn from Percival Street to Shape Street East
Maneuvering Problems Cause Safety Issues. Potential Conflict of Vehicular Traffic and Tram
大型車輛較難從波斯富街右轉入駱克道導致安全問題。車輛與電車有潛在相撞危險

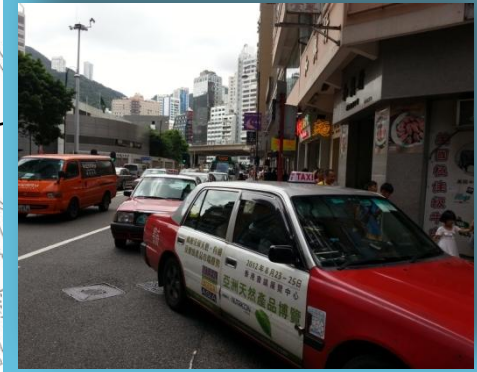
Long Traffic Queue at Matheson Street
勿地臣街出現較長車龍

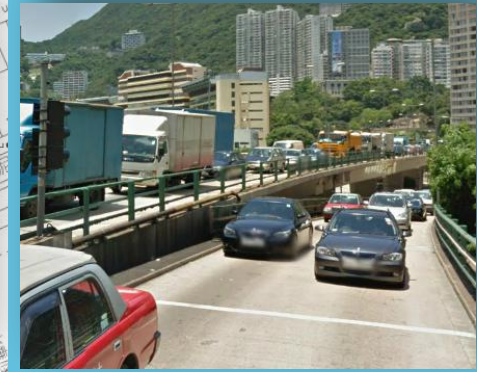
Frequent Weaving Movements at slip road (from Wong Lai Chung and Flyover of Canal Road West)
車輛於橋面支路(由黃泥涌道至堅拿道西天橋)頻密穿插而行

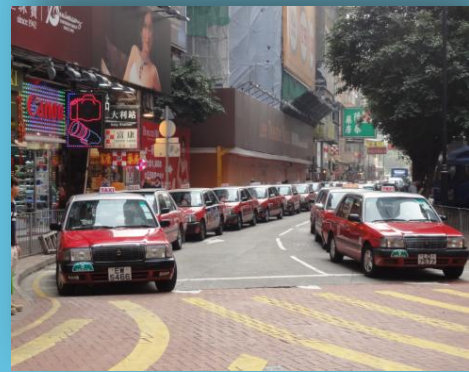
Long Taxi Queue from Russell Street
Queuing back to Matheson Street
較長的士車龍由羅素街延伸至勿地臣街

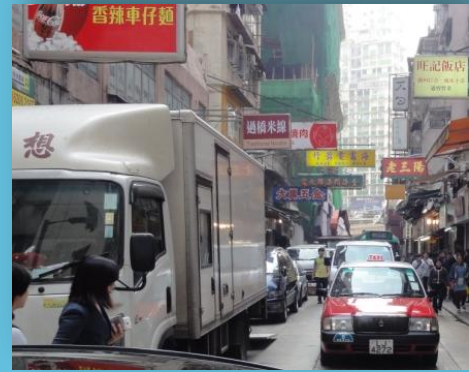
Carriageway Width Occupied by Parking Vehicles at Tang Lung Street
登龍街行車道被停泊車輛佔據

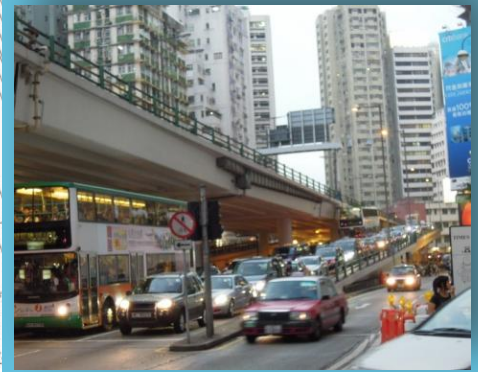
Long Traffic Queues at Canal Road East F/O
堅拿道東天橋出現較長車龍

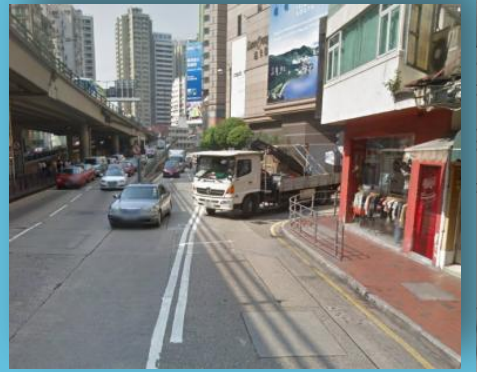
Frequent Weaving Demand along at-grade Section of Canal Road East
車輛於堅拿道東地面路段頻密穿插

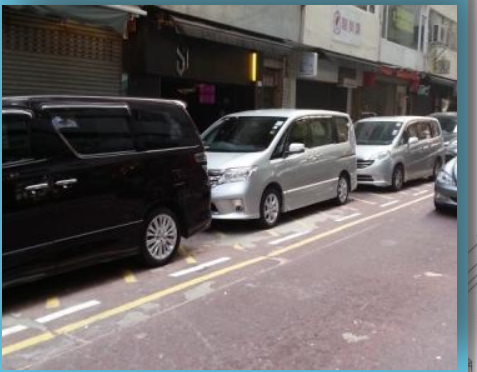
Illegal Parking at Yiu Wa Street
車輛於耀華街非法停泊

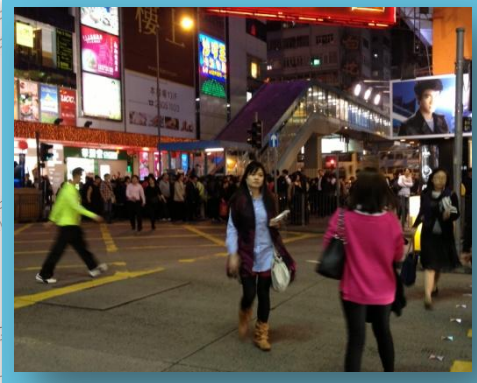
Heavy Pedestrian Demand and Jaywalking at Junction of Percival Street / Lockhart Road
 大量行人使用波斯富街 / 駱克道路口並出現亂闖馬路情況

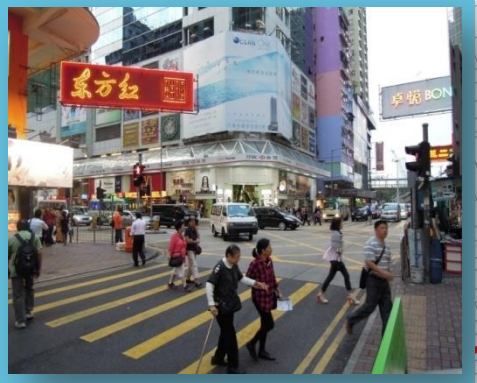
Jaywalk at the Junction of Lockhart Road/Percival Street
 行人於駱克道 / 波斯富街路口亂闖馬路

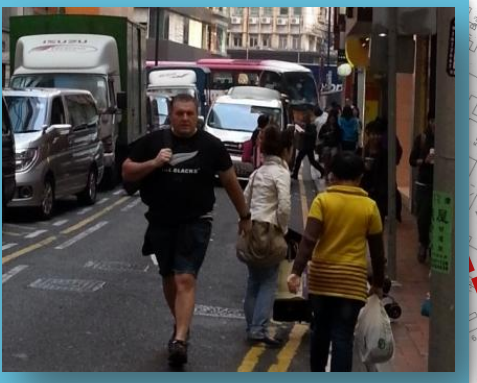
Narrow Footpath at Sharp Street East
 雲東街行人路狹窄

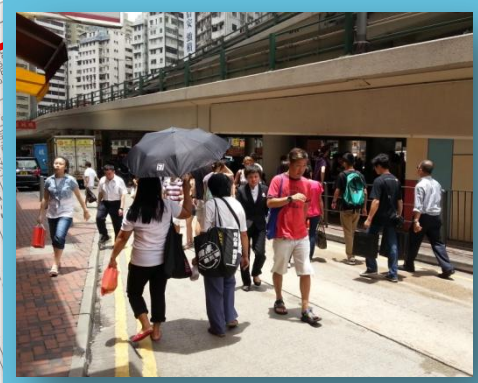
Narrow Footpaths at Canal Road West
 堅拿道西行人路狹窄

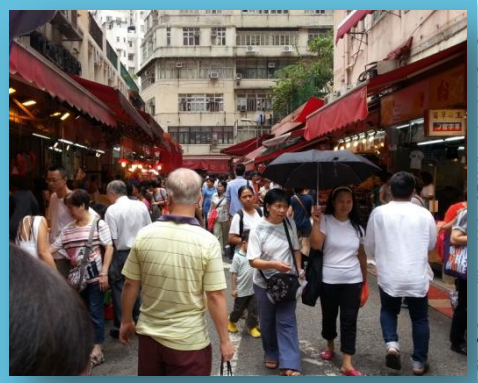
Reduction of Capacity of Carriageway due to On-street Activities at Wan Chai Road
 灣仔道上的活動導致行車道容車量減少

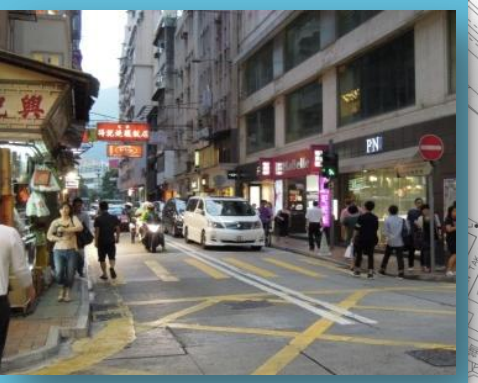
Narrow Footpaths at Matheson Street
 勿地臣街行人路狹窄
